Typhoon/Tempest

in action

By Jerry Scutts

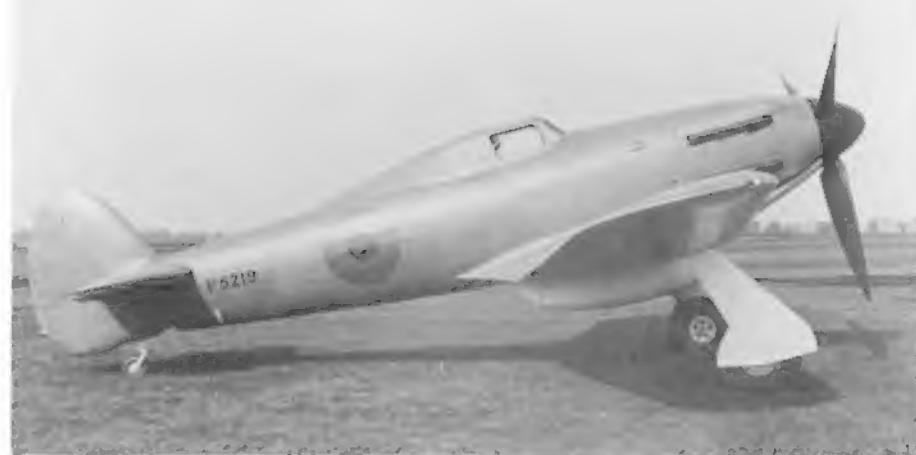
The Hawker Tornado prototype (P5219) was powered by a Rolls-Royce Vulture engine and featured two rows of exhaust stacks on either side of the nose. The prototype made its first flight on 6 October 1939.

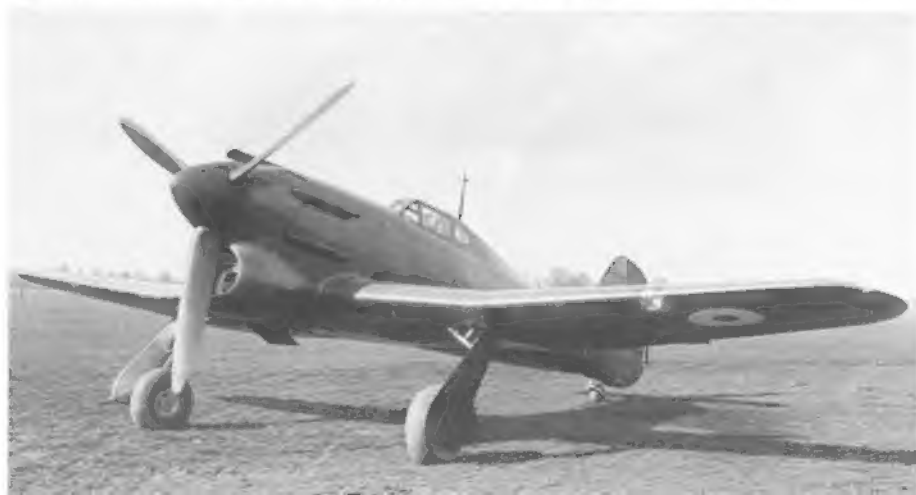
The Tornado prototype was later modified with the radiator being relocated under the nose. The aircraft also featured two small windows in the solid fairing behind the cockpit. Like all RAF experimental aircraft, the prototype carried bright yellow undersurfaces.

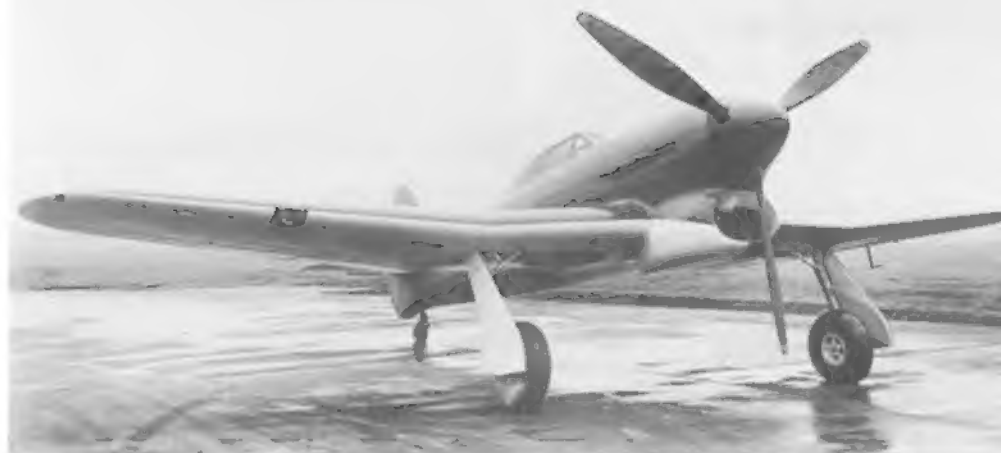
The first Typhoon prototype (P5212) was powered by a 2,020 hp Napier Sabre I engine and made its first flight on 24 February 1940 with Hawker test pilot Philip Lucas at the controls.

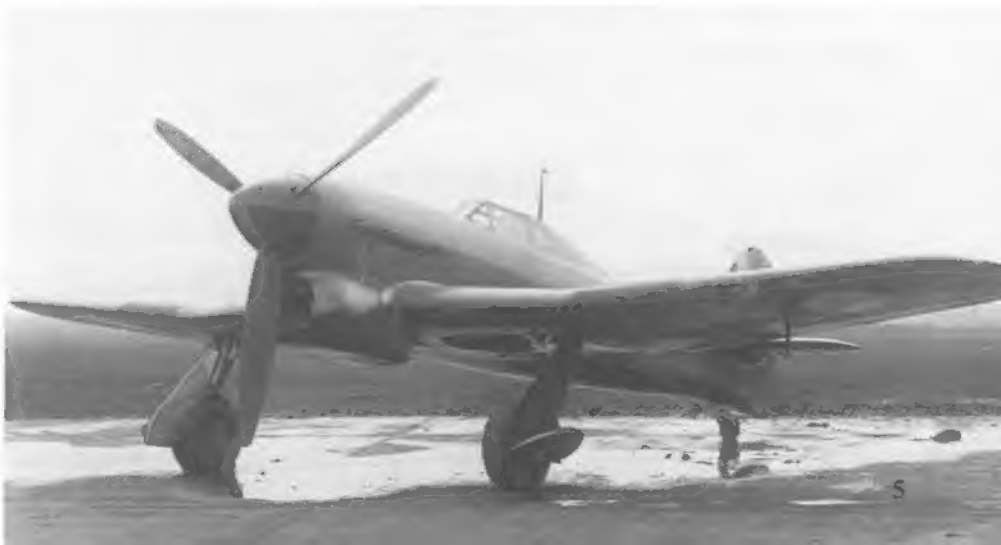
The second Typhoon prototype featured hinged wheel well doors on the landing gear legs, which were deleted on production aircraft in favor of separate doors. The prototype also had small windows mounted in the solid fairing behind the cockpit.

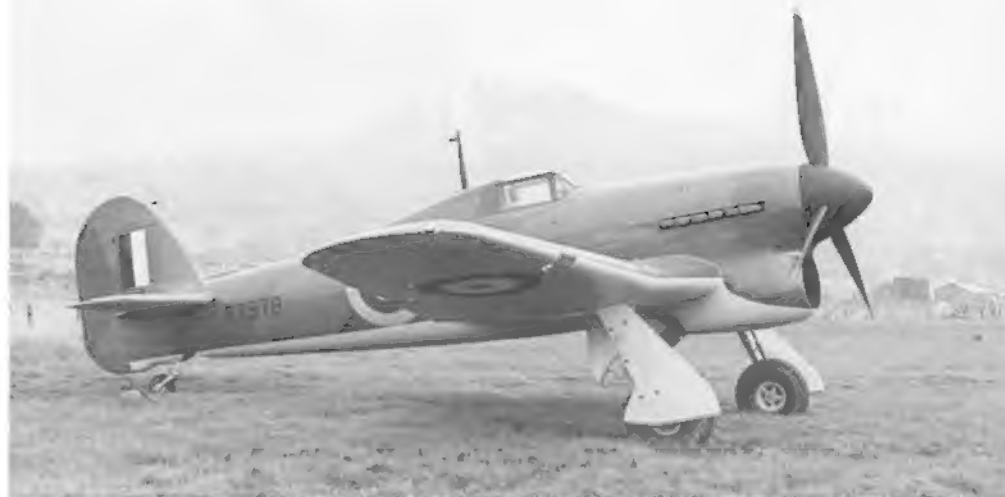
This early production Typhoon IA (R7578) lacks the small windows behind the cockpit found on the prototype Typhoon. The aircraft is armed with a total of twelve Browning .303 machine guns, six in each wing.

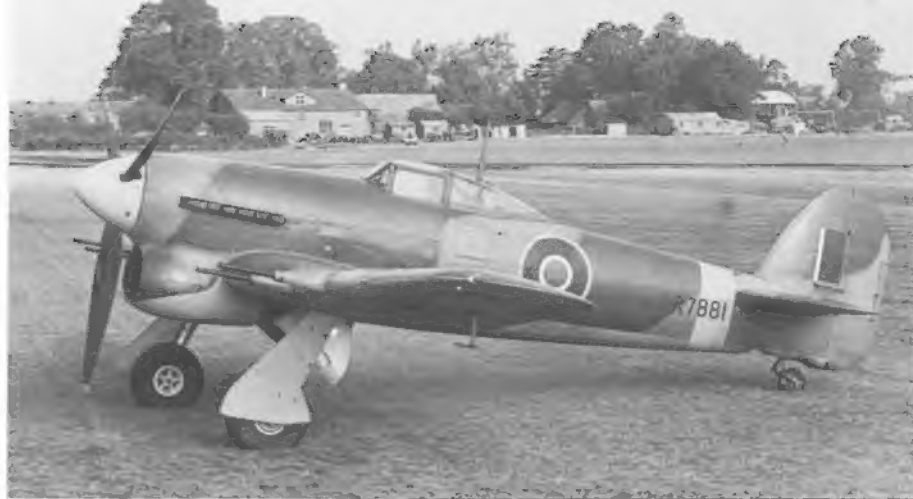
This early Typhoon IB is armed with four Hispano 20mm cannons with unfaired gun barrels, similar to the mounting found on the Hawker Hurricane IIC. The solid fairing behind the cockpit has been replaced by a fixed clear fairing which greatly improved the pilot's rearward view.

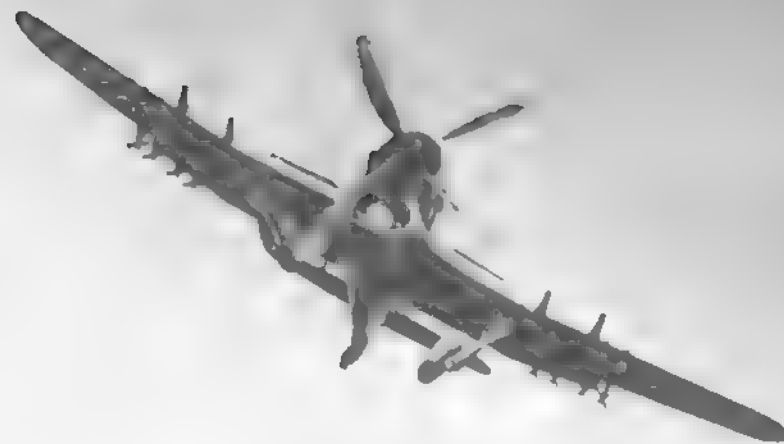
A Typhoon IB climbs out from a forward airfield armed with eight 60 pound rockets for another ground attack sortie. This is a late production Typhoon IB with a four blade propeller.

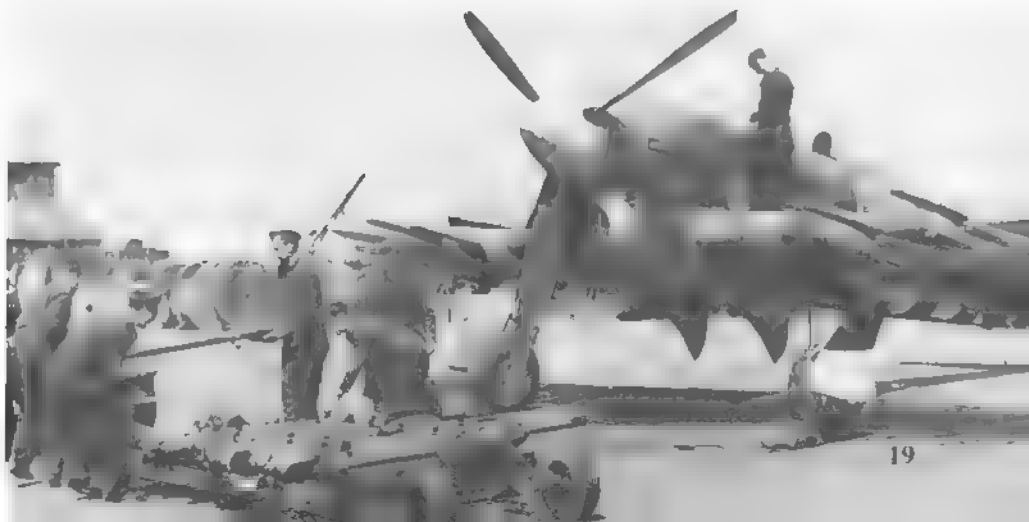
Ground crewmen load 60 pound rockets on the wing racks of a Typhoon IB of the 2nd Tactical Air Force. Each Typhoon could carry eight rockets, making them a potent ground attack weapon against German armor.

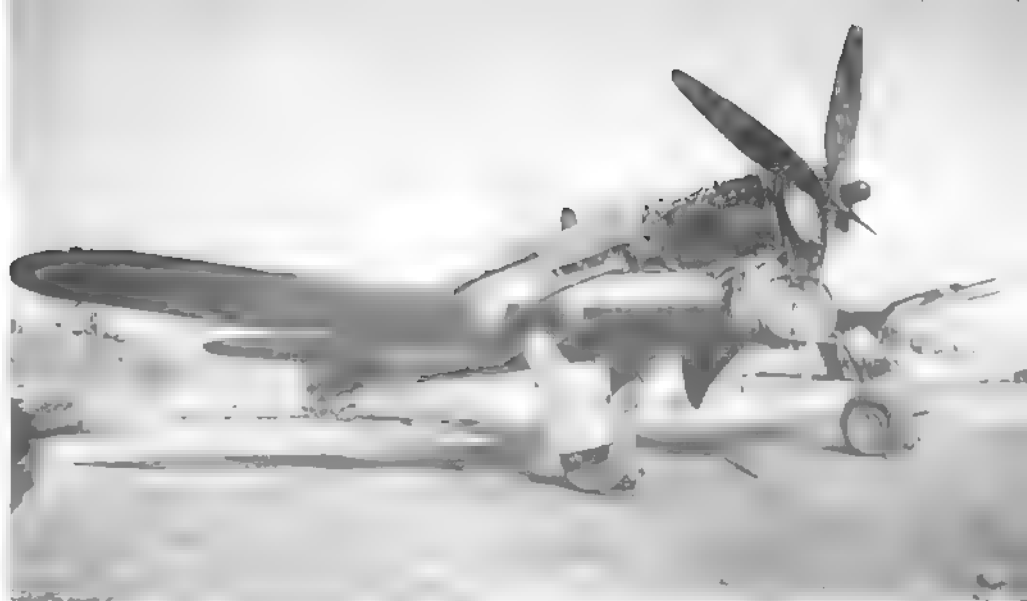
This late production Typhoon IB of No 440 Squadron has the cowling panels removed so that maintenance personnel can work on its engine at Eindhoven, Holland, during the Spring of 1945. The Sabre engine required a lot of preventive maintenance.

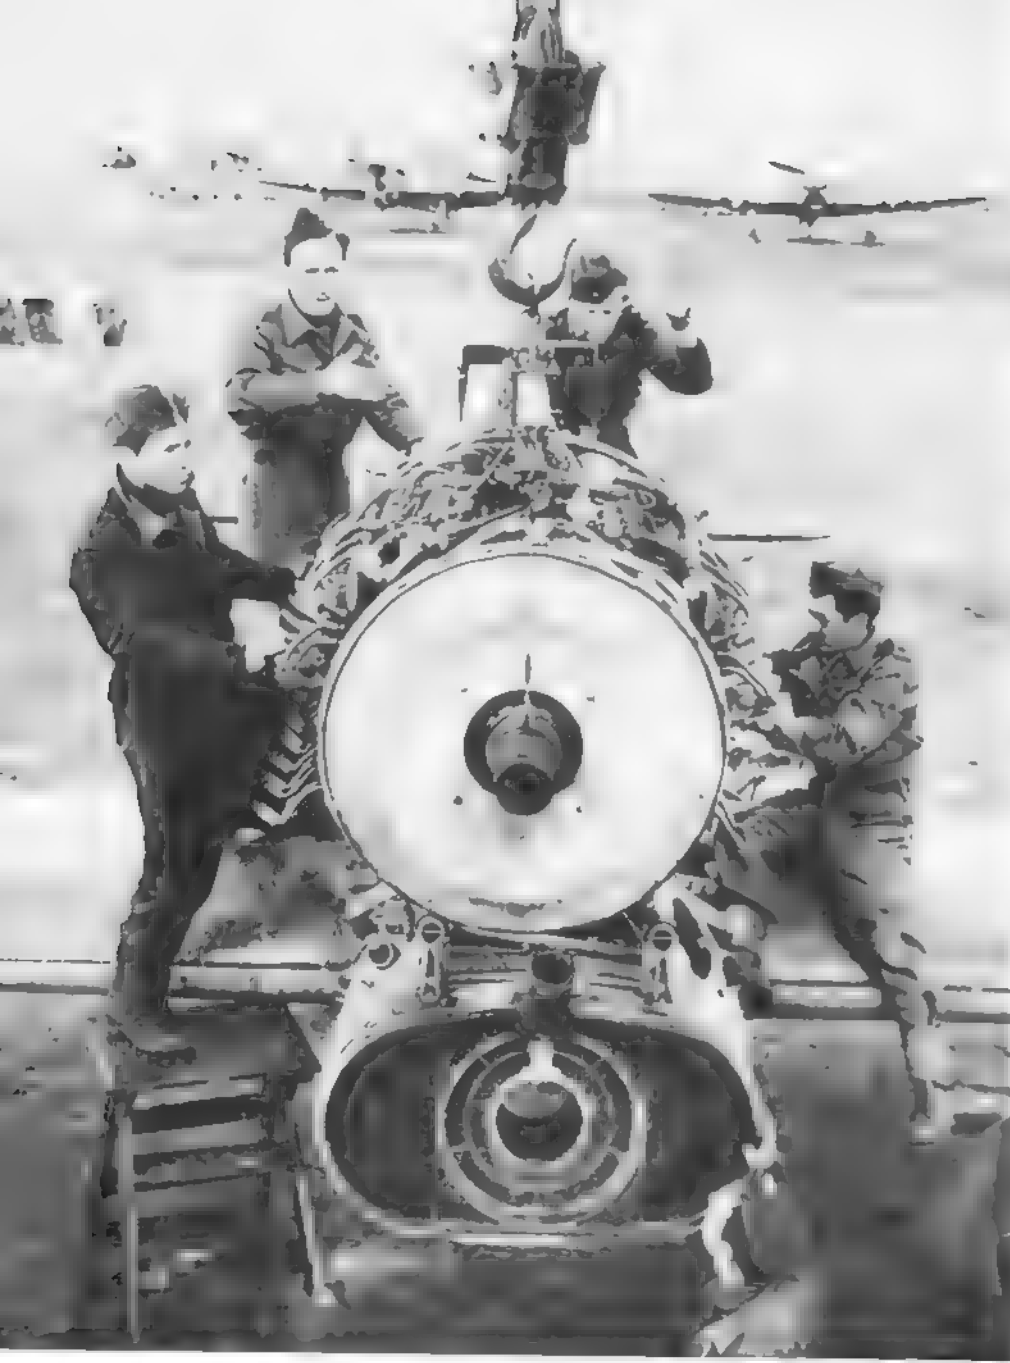
Five maintenance fitters lift the Sabre engine from a Typhoon IB at Eindhoven, Holland. The large pipe protruding above the radiator was the main connection line between the engine and the radiator.

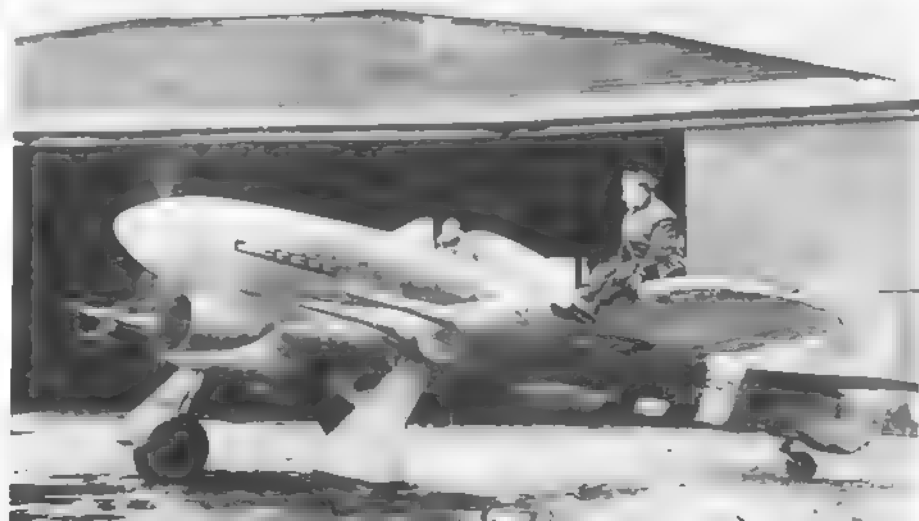
Burned out and damaged Typhoons on the field at Eindhoven, Holland, on 1 January 1945. These Typhoons of No 439 Squadron were among the nineteen lost when the Luftwaffe attacked the field. No 439 Squadron had only one Typhoon destroyed and one damaged during the raid.

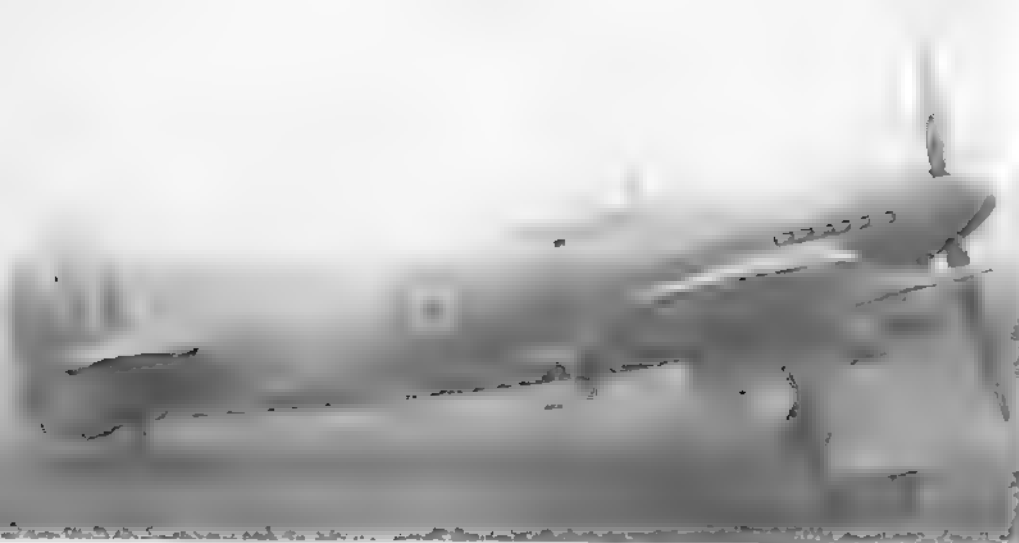
A number of Typhoons were modified for the reconnaissance role under the designation Typhoon PR Mk IB. This PR Mk IB (EK427) of No 4 Squadron during March of 1945 has a camera replacing the starboard inboard cannon.

The starboard inboard cannon fairing of this Typhoon PR IB (EK427) reveals the lens of a five inch forward facing oblique camera. This camera was used to record the damage done to targets during strikes by rocket and bomb armed Typhoons.

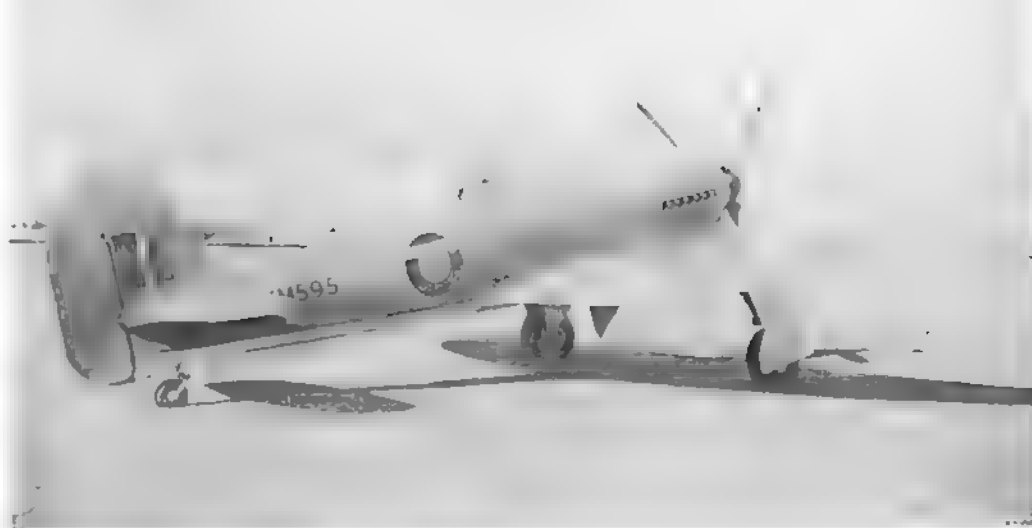
This Typhoon (HM595) was used as a prototype for the Tempest program. The aircraft has not yet been fully converted and retains the Typhoon's car door type pilot entry and early style canopy.

As part of the Tempest program HM595 was fitted with a fin fillet in front of the vertical stabilizer. The white line on the fuselage was a painted datum line used for photographic reference during filming of the test flights.

HM595 was later used to flight test various systems for both the Tempest V and VI. During this test flight it is fitted with equipment intended for use on the Tempest Mk VI, the final mark of Sabre powered Tempests.

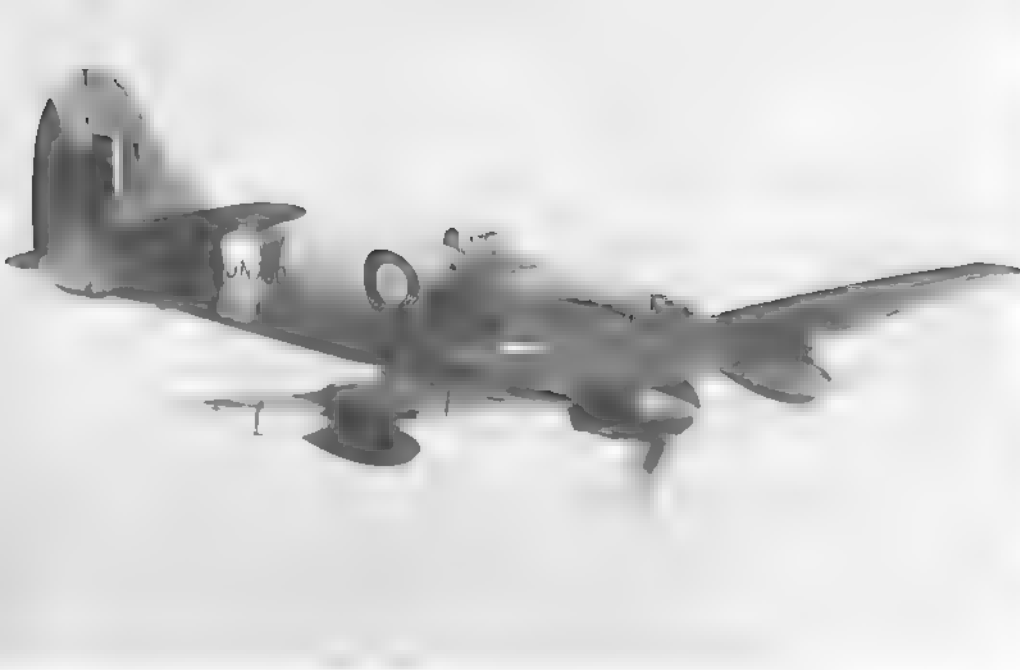
The second production Tempest V (JN730) was used to test fly the Hawker designed forty-five gallon teardrop shaped underwing fuel tanks. The tanks were approved for use and became a standard item of equipment for Tempest squadrons.

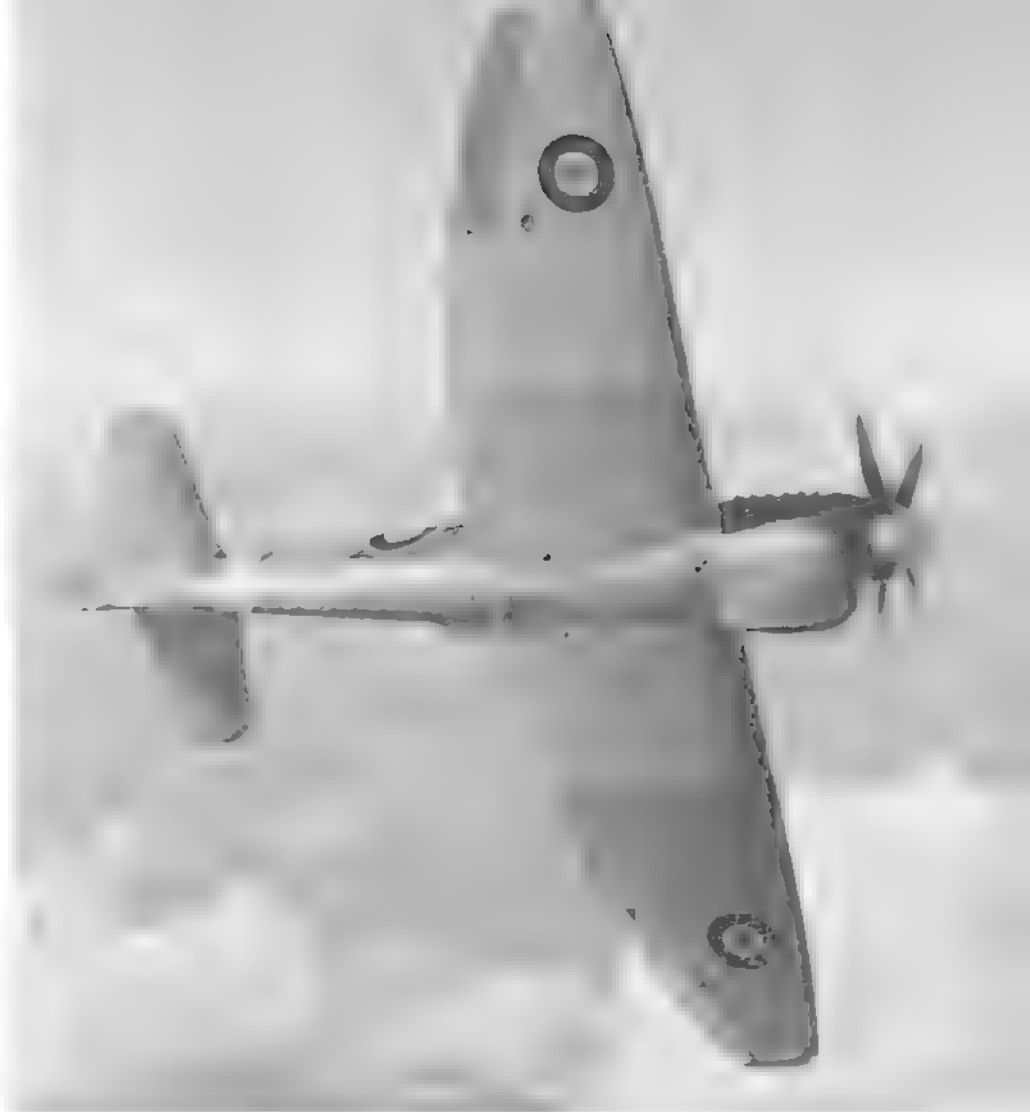
(Left) Like the earlier Typhoon, the Tempest V also carried underwing recognition stripes. This Tempest has the early Mk II cannons with barrels that extended beyond the wing leading edge, covered by short fairings.

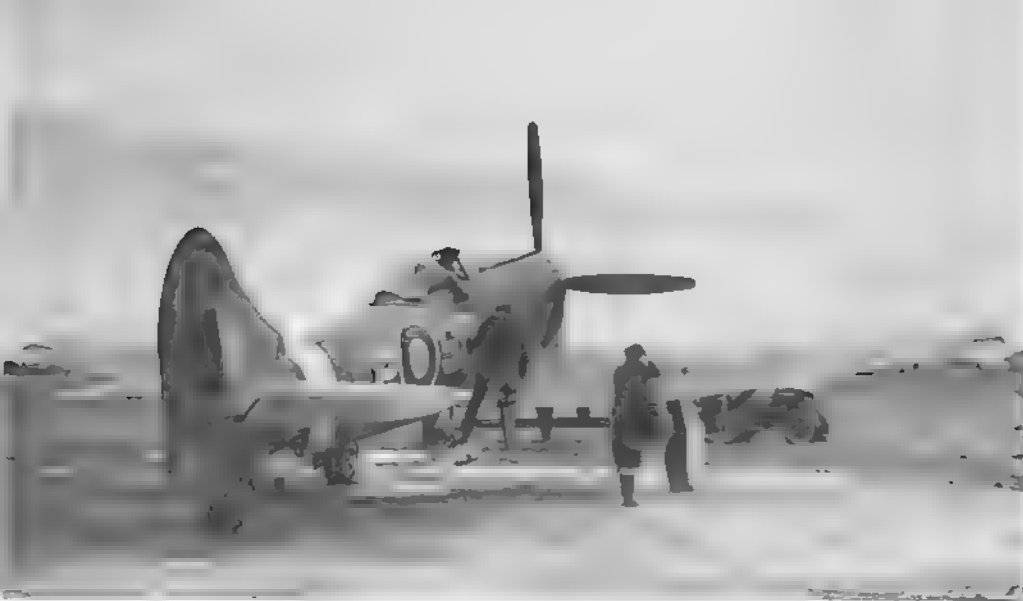
On 19 October 1944, the British public was informed by the newspapers that the RAF had a potent new fighter. This Tempest Mk V (EJ608) of No 501 Squadron at Bradwell Bay, was one of the aircraft featured in the announcements and carries the recently introduced forty-five gallon streamlined drop tanks.

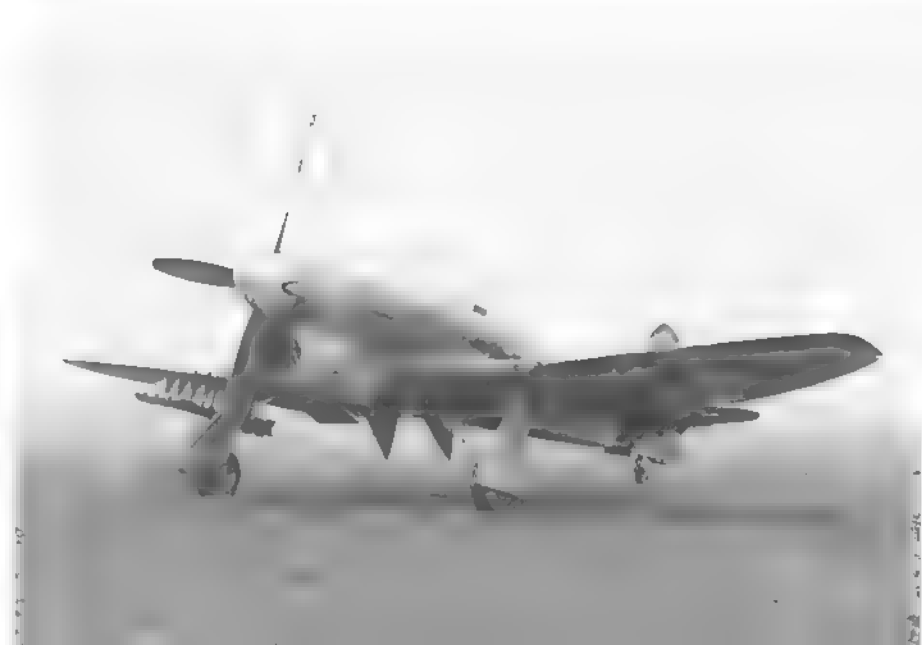
Although the Tempest, unlike the Typhoon, did not use rockets operationally during the war, the Tempest Mk V was tested and cleared to carry eight rockets on Mk VIII zero length launchers.

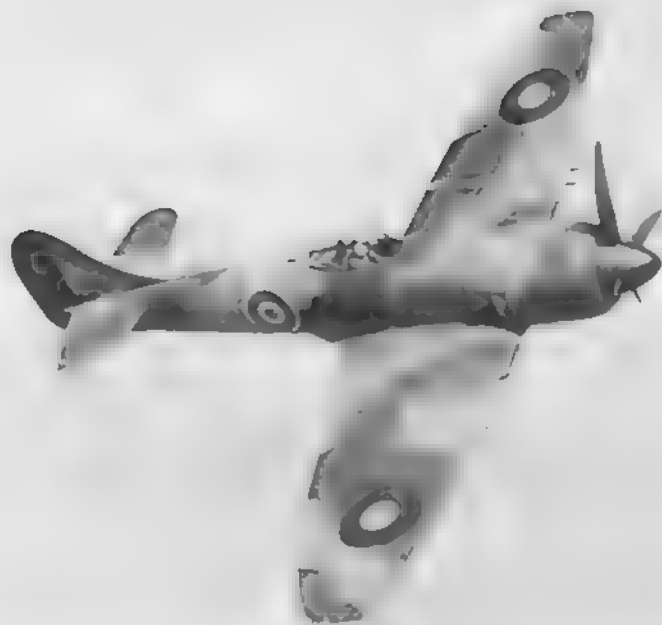
The prototype Tempest II (LA602) was armed with the early long barreled Hispano Mk II cannons that extended beyond the wing leading edge. Originally, the aircraft had been fitted with a Typhoon style tail.

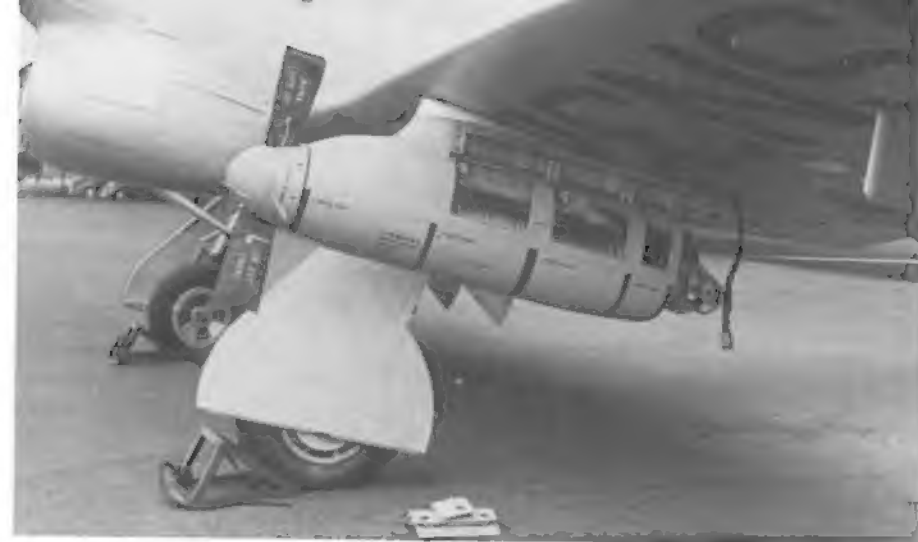
The compact winch and cable system was enclosed by a streamlined pod and carried under the port wing. The pod was counter balanced by a drop tank carried on the starboard wing. Although successful, the pod did not enter production.

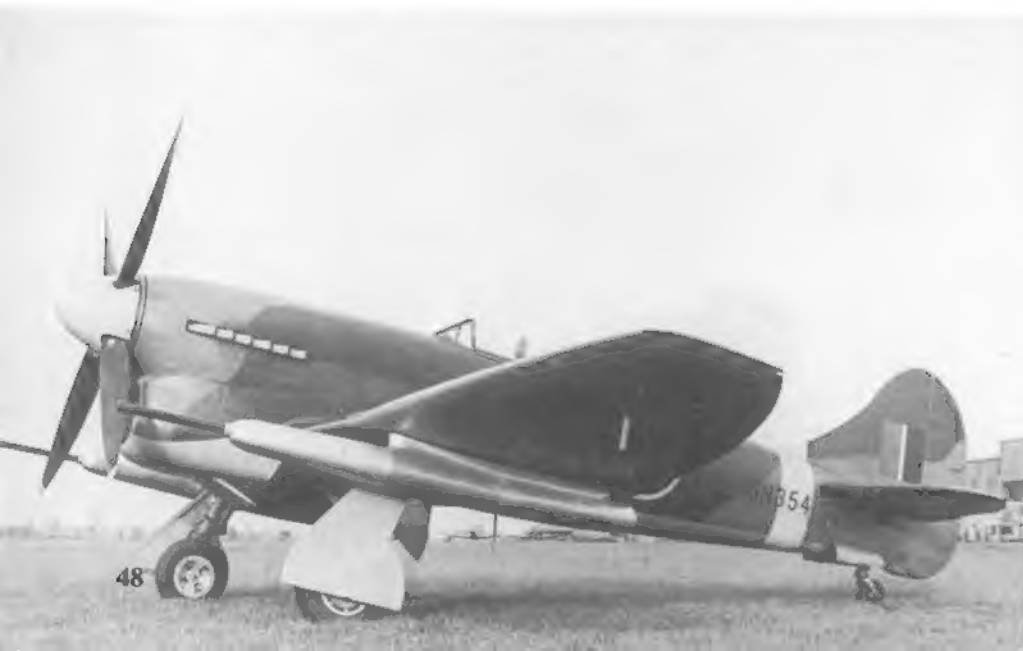
Among the armament tests conducted with the Tempest was the Vickers 40 mm P gun. The large cannons were faired into slim, streamlined pods and carried on the bomb racks of the Tempest. This Tempest V (SN354) served as a weapons test bed for the firing trials of the cannon.

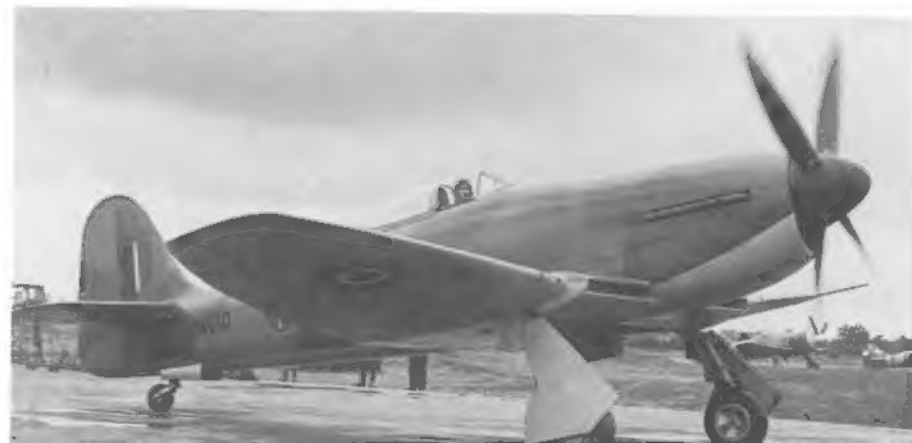
The Tempest Mk III was the last of the Tempest line and led to the RAF Fury and Royal Navy Sea Fury. Known as the Hawker F.2/43, the aircraft made its first flight during September of 1944 powered by a Griffon engine.

Finally, the Tempest Mk III and IV, both earmarked for installation of Rolls-Royce Griffon engines, diverged significantly from the Sabre engined Tempest program. Only the Mk III prototype (LA610) was actually converted. The aircraft was test flown as a "lightweight" Tempest as part of a series of design studies that eventually led to the Hawker Fury and Sea Fury fighters.

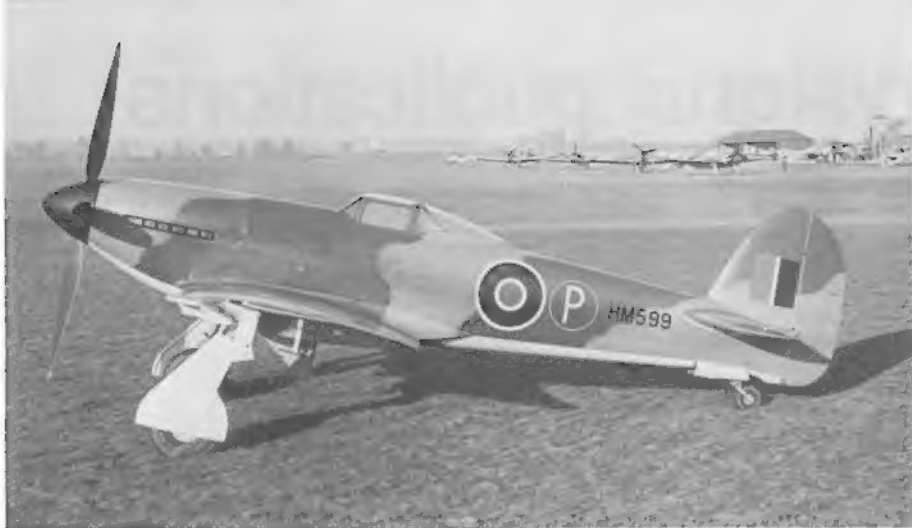
The prototype Tempest I (HM599) was modified with air intakes for the oil cooler and radiator in the wing leading edge. In the event these did not offer sufficient cooling for the engine and the project was cancelled.

In a separate design study, Camm had devised a pair of wing leading edge mounted radiators to replace the cumbersome chin radiator of the Typhoon. Similar in design to those used on the Mosquito, these radiators were estimated to reduce drag by nearly two-thirds.

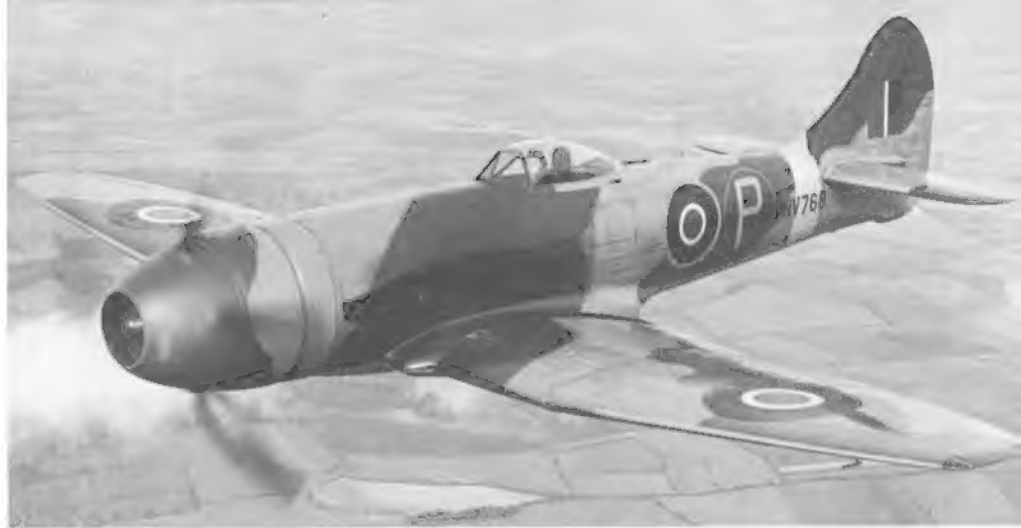
This Tempest (NV768) was fitted with a ducted spinner as part of the flight trials of Napier's annular radiator. In the event, this modification failed to live up to expectations and did not enter production.
